# Manhole Inspection Summary

Manhole # S57C\_\_008MH

**Inspection** ☐ Is Incomplete Rating: **4) Poor**

**Location** Address: **3800 E.Baltimore St.**

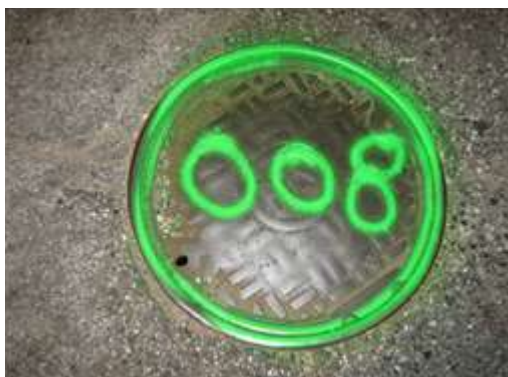
Miscellaneous

Condition: **Worn**

MH Lid worn

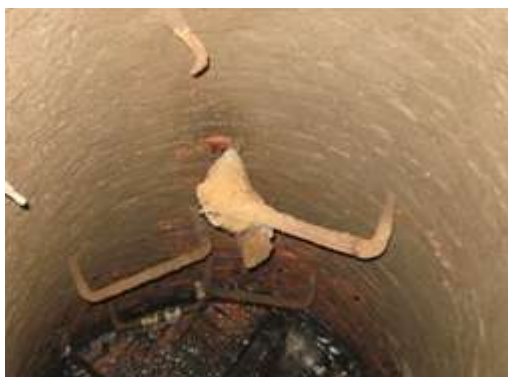
Defect 6

Count: **5** Missing: **1** ☒ **Corroded**

☒ **Evidence Of Surcharge** Depth: **5** (ft.) ☐ Active Surcharge Present

1 missing rung and surcharge evidence on corroded rung

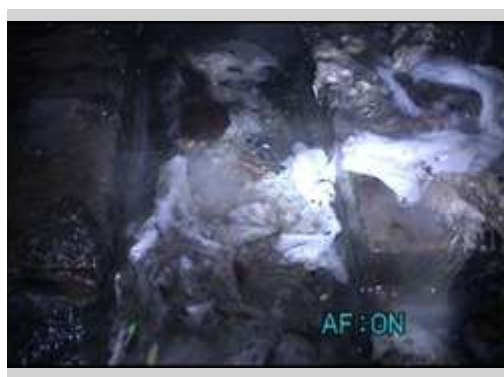
Defect 3

Condition: ☐ Sound ☐ Cracked ☐ Root Intrusion ☐ Deteriorated ☐ Leaks ☒ **Debris**

debris in channel

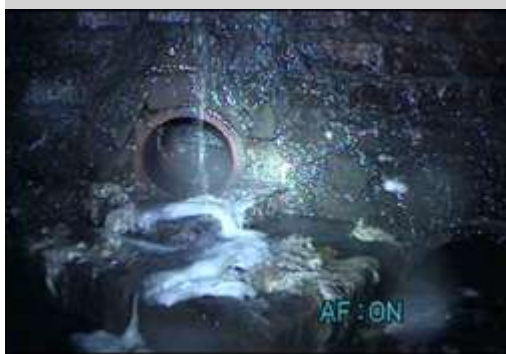
### Defect 1

Condition: ☐ Sound ☐ Cracked ☐ Root Intrusion ☐ Deteriorated ☐ Leaks ☒ **Debris**

debris on the bench

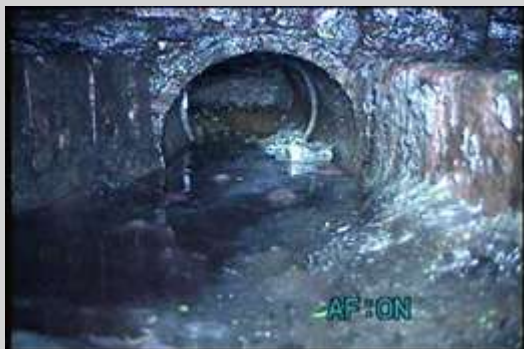
3 O'Clock Inflow

Pipe Height: **8.4** (in.) Rod and Bar (Angled)  
Pipe Material: **Clay** ☐ Pipe Lined  
Invert Depth: **10.04** (ft.) Flow Characteristics: **None**  
Deposits: ☐ None ☐ Mud ☒ Sludge ☐ Debris ☐ Grease  
Silt Depth: **2** (in.) Deposits Extent: **Light**  
Infiltration: **None** Pipe Seal Cond: **Sound**

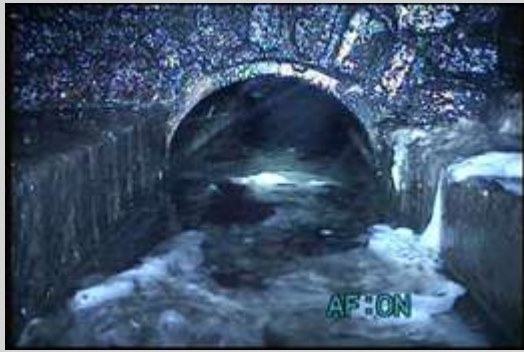
6 O'Clock Inflow

Deposits: ☐ None ☐ Mud ☐ Sludge ☒ **Debris** ☐ Grease

Silt Depth: **3** (in.) Deposits Extent: **Medium**

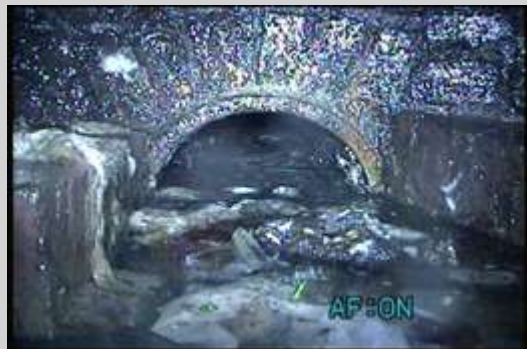
9 O'Clock Inflow

Deposits: ☐ None ☐ Mud ☐ Sludge ☒ **Debris** ☐ Grease

Silt Depth: **3** (in.) Deposits Extent: **Medium**
